SERVICE BULLETIN

from: TRIO-KENWOOD COMMUNICATIONS, INC.

SUBJECT: TS-180S DFC INSTABILITY

DATE 7/13/79

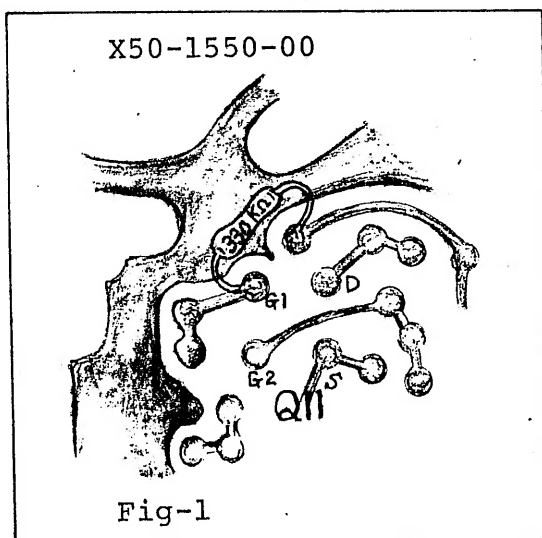
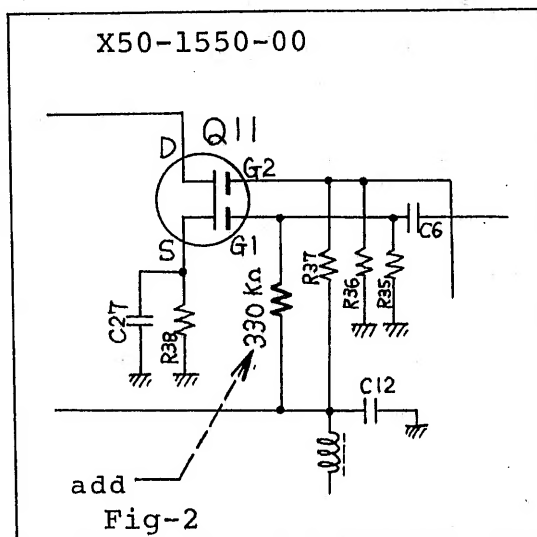
TS-180S operators may report intermittent DFC instability, especially at 10Khz even points. This may be characterized in some cases as FM'ing.

On page 37 of the Service Manual, the Board view of the VCO unit contains reversed callouts for Q11 & Q15 FET's. D & S, and G1 & G2 are transposed.

On the VCO unit X50-1550-00, install a 330K ohm resistor between Q11 G1, and the 8V line. Connect from L7 at C12 to Q11 G1, at R35.

No adjustments are necessary.
